## MONITORING INTERFACIAL DEGRADATION IN METAL-COATINGS USING LASER-ABLATION TECHNOLOGY (ICP-MS)

\*AE Pillay<sup>1</sup>, S Fok<sup>2</sup>, S Stephen<sup>1</sup> and A Abd-Elhameed<sup>1</sup>  
<sup>1</sup>Department of Chemistry, <sup>2</sup> Department of Mechanical Engineering  
The Petroleum Institute, PO Box 2533, Abu Dhabi, UAE

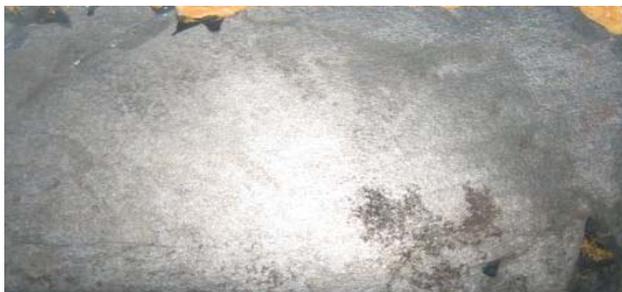
Fig. 1. Coated steel sample showing early stages of degradation.

Clearly, if the coating incurs partial deterioration or damage, this would be reflected in the time-spectrum. Figure 1 delineates surface peeling around some edges. It is surmised that ‘flaking or peeling’ of this nature could be due to some form of sub-surface attenuation accompanied by a loosening of the protective coating. At this stage the only evidence to support this comes from laser irradiation of the spots on the surface in close proximity to these areas of instability. Such irradiations
